Seagate Inspections, Inc.
8860 Airport Hwy.
Holland, OH 43528

Client Information: Record Number Sample

Buyer, Home
1234 Any Street
Any Town, US

Inspected 4/16/12 8:30 AM

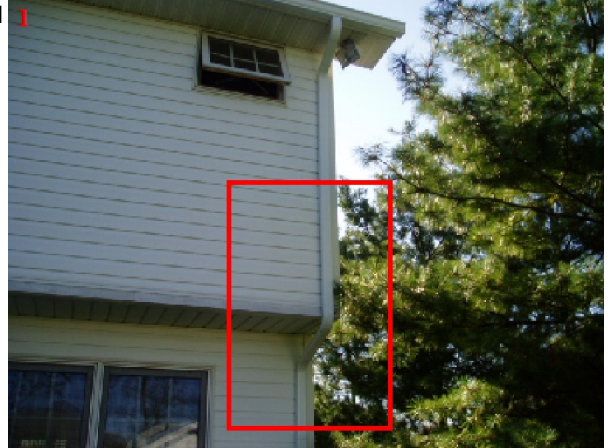
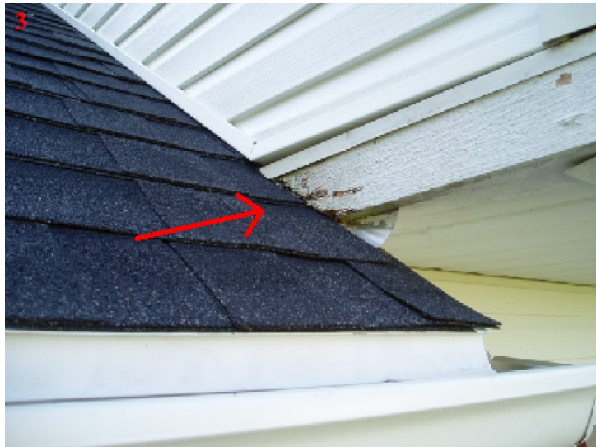
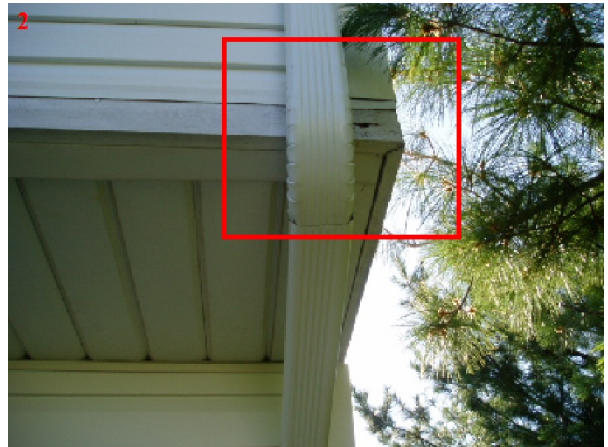
Trim /Soffit /Fascia Type - Wood, Metal, Decaying Wood

Rot / Wood decay was found at the south rear corner(looking at the house from the rear it is located at the right hand corner - photos 1 and 2). This is an example and sampling of the wood used on the exterior of this home. Additionally there is wood decay visible from the rear at the north roof and sidewall juncture.

A qualified contractor should provide a full evaluation of all wood used on the exterior of the house and make any necessary repairs. Wood used for trim, soffit, and fascia is prone to rot and must be regularly monitored and maintained.

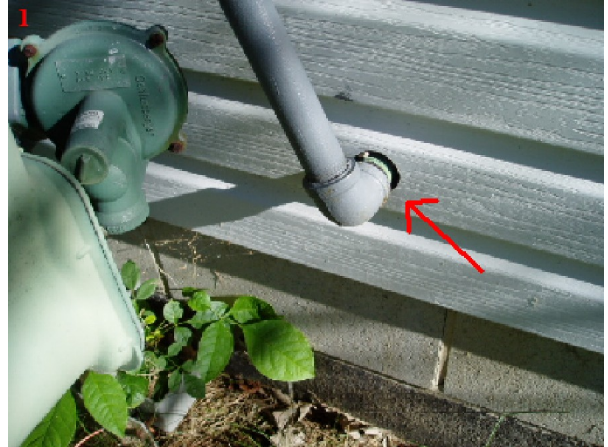
Service / Repair **Siding Observations - Penetration Inadequately Sealed**

All penetrations through the siding should be better sealed. Open gaps or seams at penetrations allow infiltration of moisture, unwanted pests, etc.

Sealer should be applied where openings that allow a transfer point from the exterior to the interior are present.

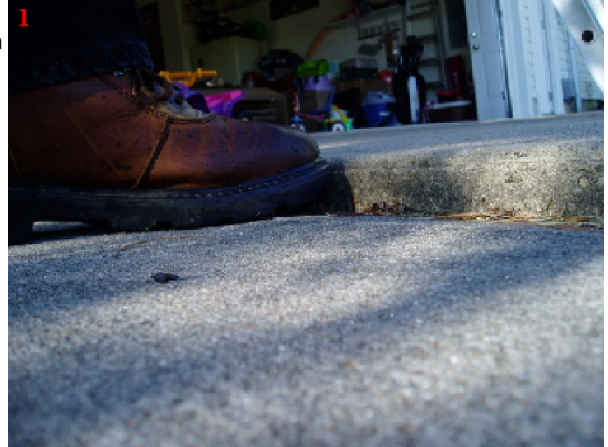
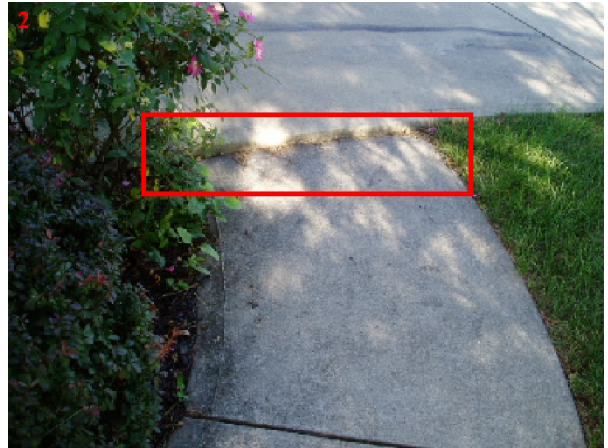
Observations at Walk/ Patio/ Step - Walkway Settlement, Tripping Hazard

Settlement has occurred at the front walkway. Improve as necessary. There are options to full replacement and slab/mud jacking may be an option. When any non-permeable surface settles towards the foundation rain or surface water is directed back against the foundation increasing the likelihood of seepage into below grade spaces.

Uneven surfaces at the walk and drive present a tripping hazard and should be addressed.

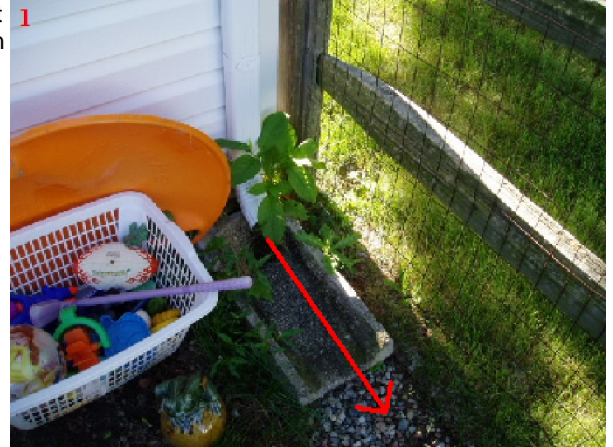
Gutter/Spout Observations - Inadequate Extension

All above grade downspouts should be extended to discharge at least six feet away from the foundation. This will help ensure the prevention of seepage into below grade spaces and differential structural settlement caused by roof runoff water being dumped next to the structure.

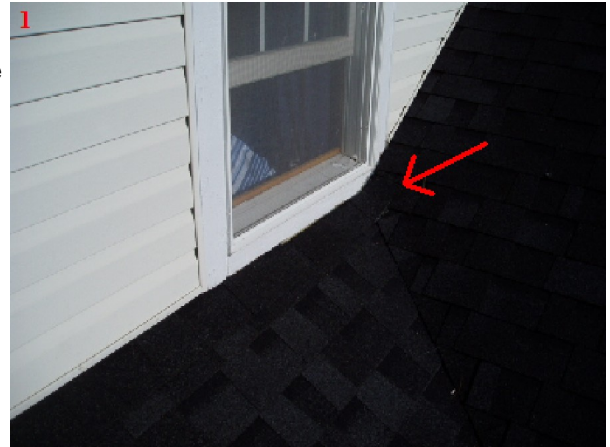
Vulnerable Areas - All Roof Penetrations, Soil Stack Boots, Sidewalls, Valleys

Any penetration through the roof is vulnerable to leakage. Leaks often appear at penetrations, flashings, changes in direction or pitch, and material types. Monitor all penetrations and perform maintenance as necessary to prevent leaks. Note the photo shows the front bedroom window where caulking has been applied in the past.

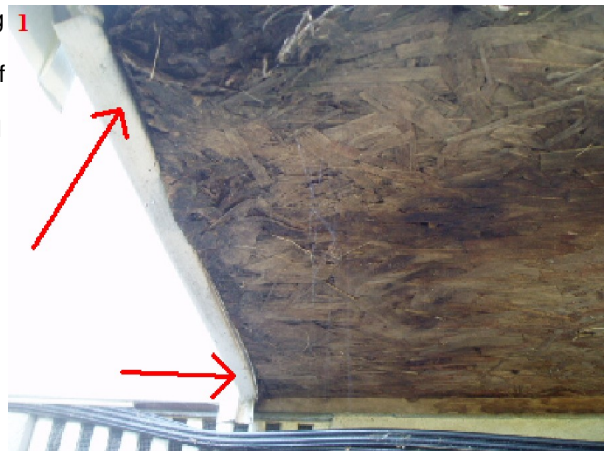
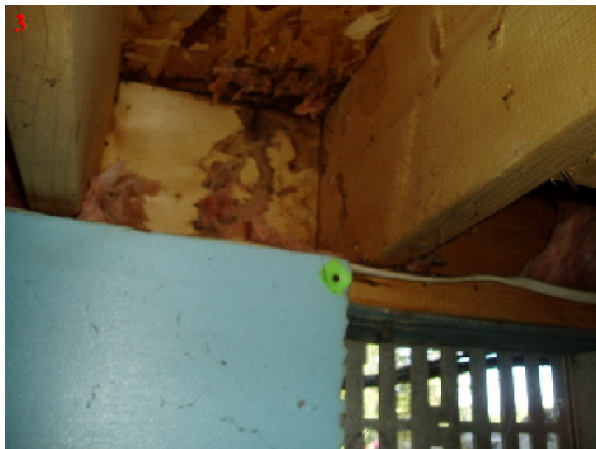
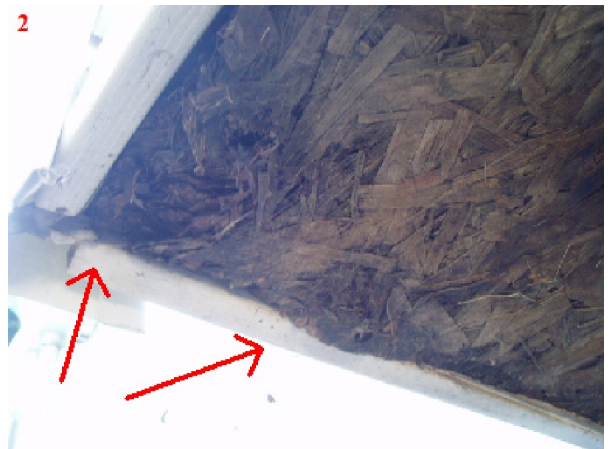
Major Concern Chimney Observations - Further Evaluation Advised

The wood (OSB) panel at the bottom of the chimney chase is showing signs of decay due to moisture. There is also visible staining visible from the crawlspace in the general area of the chimney. The source of the moisture is or was the flashing at the roof and chimney juncture where roof runoff was allowed to penetrate and run in behind the vinyl siding. At the time of the inspection, the wood felt dry to the touch. Note that new and improved flashing may have been installed at the time of the re-roof. A qualified contractor should perform a more in-depth assessment that includes removal of siding to determine the extent of the damage to the chase structure itself as well as investigating any connection between this concern and the settlement noted in the firebox from inside. (see Fireplace).

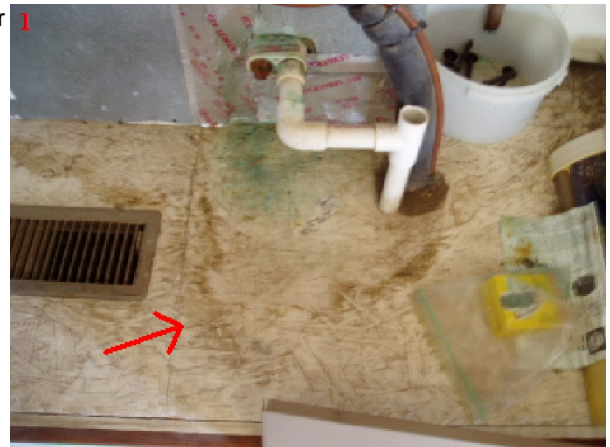
Monitor & Maintain Condensate Drain - Evidence of Past Leakage

Evidence of past condensate leakage was observed at the evaporator coil and closet floor under the furnace/air handler unit.

Past condensate leakage evidence at any number of areas related to the air conditioning system is not uncommon. Stains and/or corrosion can be signs of a past or an ongoing issue. It is recommended that a qualified HVAC contractor evaluate the concern during routine service.

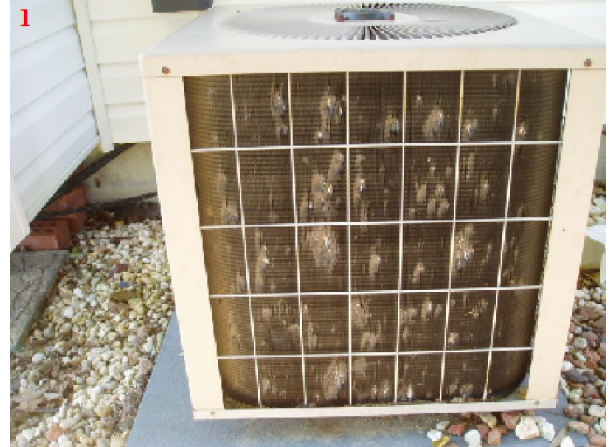
Cooling System Observations - Damaged Cooling Fins

Damage to fins on the A/C unit can cause inefficient operation. The cooling fins can be "combed" by a qualified HVAC contractor to improve air flow over the condenser coil for improved efficiency. (hail damage?)

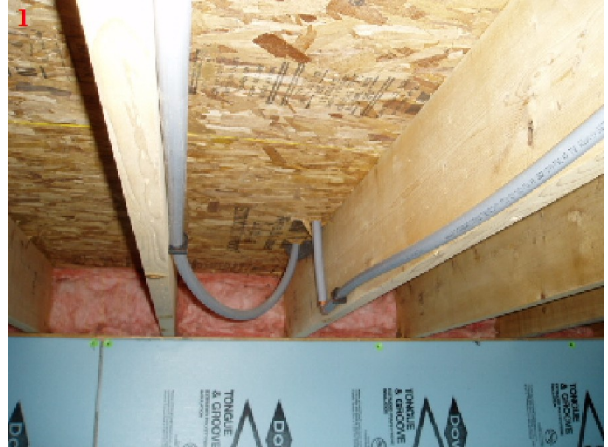
Interior Water Supply Piping - Copper, Gray Polybutylene

Polybutylene piping systems were the subject of a large class action lawsuit. Most of the problems were with the system that had aluminum crimp rings and plastic insert fittings. Systems since have been installed with copper crimp rings and copper insert fittings. This system is still an acceptable installation today though very few are actually installed. Leakage has been most common at the fittings though there remains the concern of deterioration of the piping from the inside out due to chlorine content in the water.

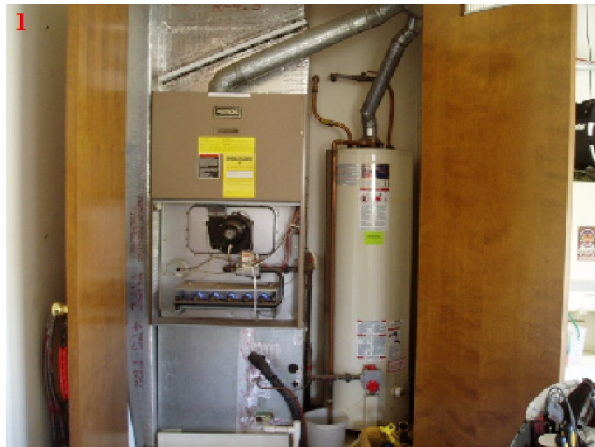
Some evidence of might be past seepage from the T&P valve on the water heater. Dry stains noted at the time of the inspection.

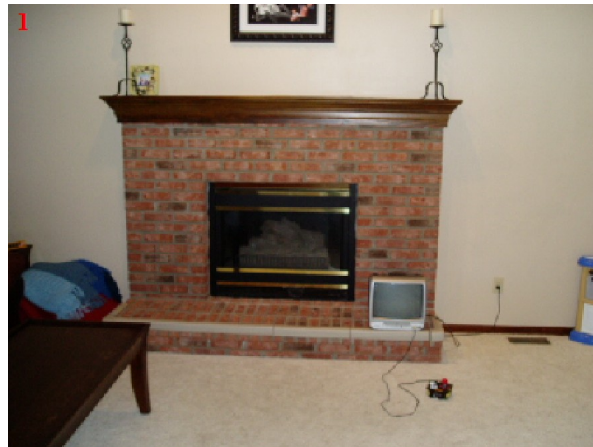
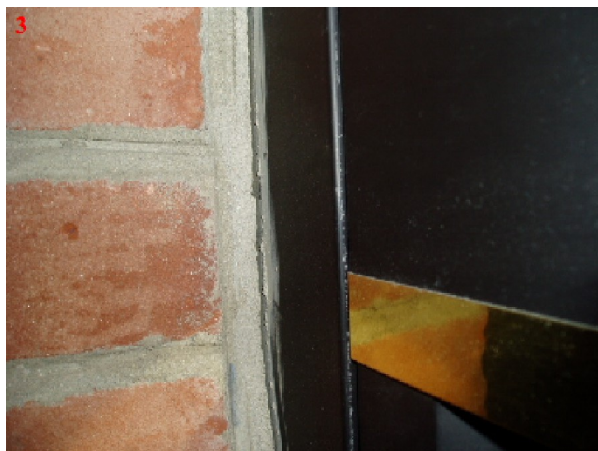
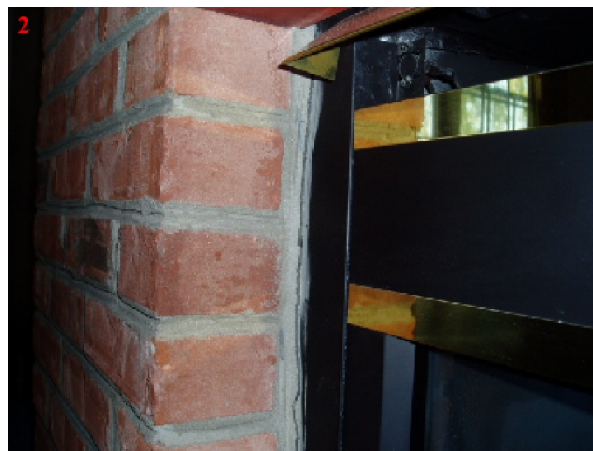
General Observations- Fireplace/Solid Fuel Burning - Firebox Settlement

Some settlement noted. This settlement may be directly linked to the issue noted with the chimney (see Chimney). The entire fireplace and related structure should be fully evaluated by a qualified specialist prior to closing.

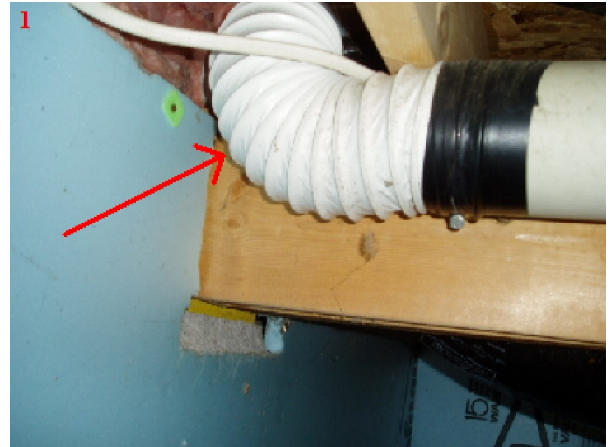
Laundry Observations - Replace Vinyl Dryer Vent Hose

The dryer vent hose is currently plastic/vinyl and should be replaced with an approved metal vent hose/pipe.
