Seagate Inspections, Inc.
8860 Airport Hwy.
Holland, OH 43528

Client Information: Record Number Sample

Buyer, Home
1234 Any Street
Any Town, US

Inspected 4/16/12 8:30 AM

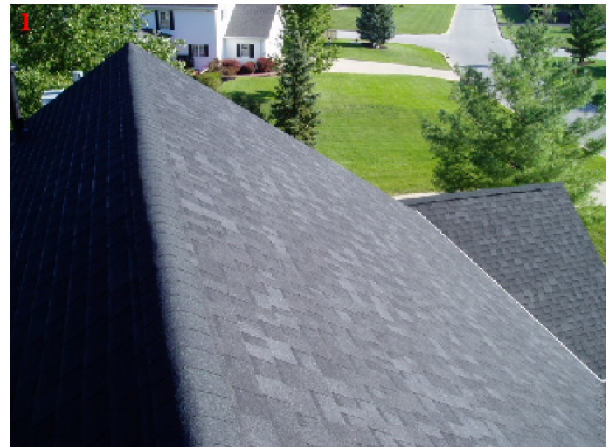
How Inspected - Walked On

The roof was viewed from walking the accessible / safe to traverse areas of the surface.

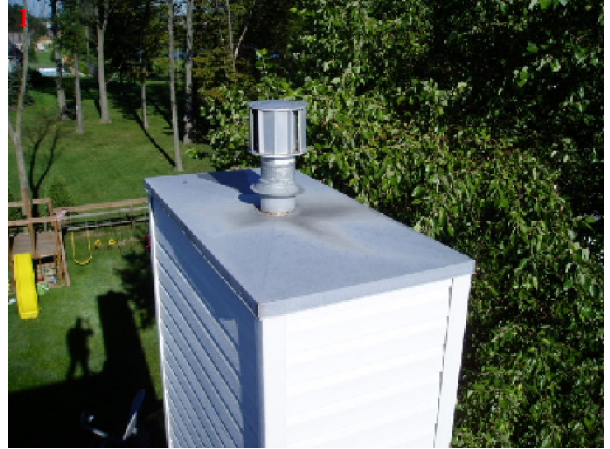
Flue Lining - Metal

Chimney Crown/Chase Pan - Metal

Chimney Flue Cap - Rain

Major Concern Chimney Observations - Further Evaluation Advised

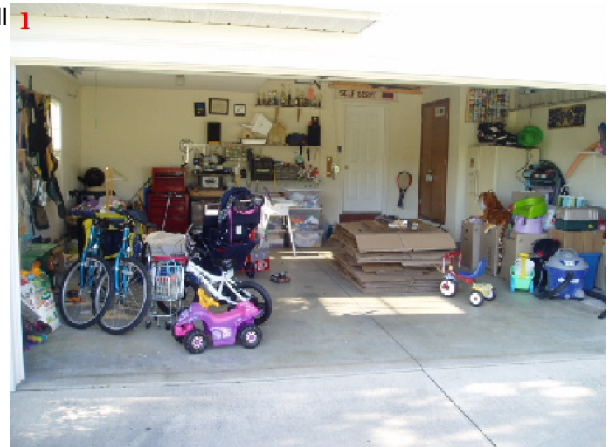
Interior Descriptions - Contents, Drywall/Plaster

Storage in the garage and particularly along the walls limits the overall view of the structure and finishes by 85% +/-.

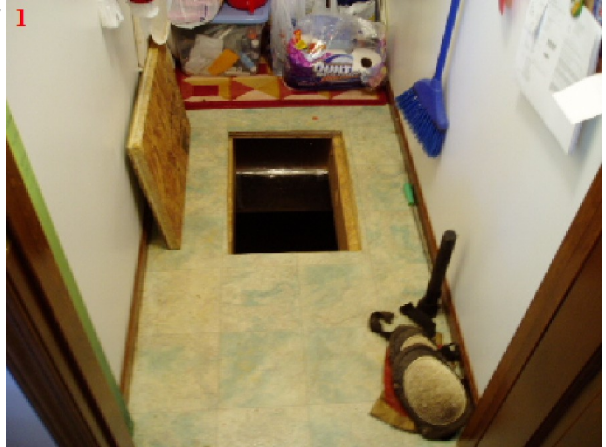
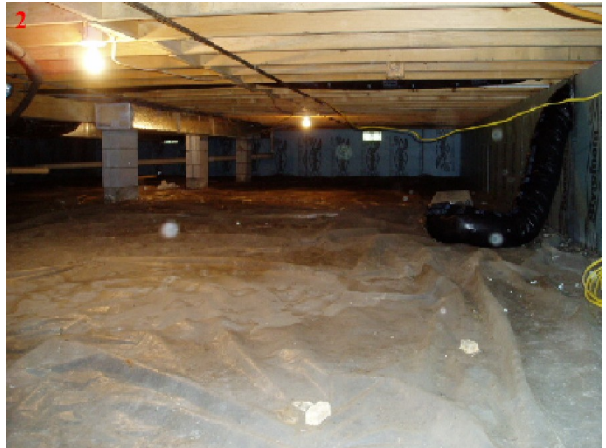
Crawl Space Access - Entered from Inside House

The crawl space was accessed from a hatch inside the house. (pantry closet).

Crawl Space Floor - Gravel with Vapor Barrier

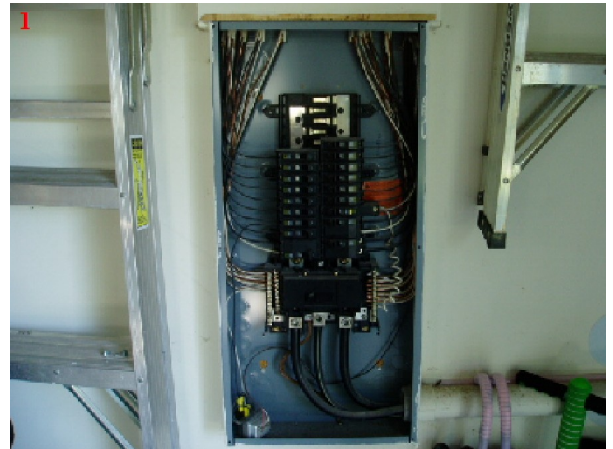
Service Rating and Description - 200 Amp., Breakers

Location of Main Panel - Garage

Main / Service Disconnect Location - Main Disconnect Located at Main Service Panel

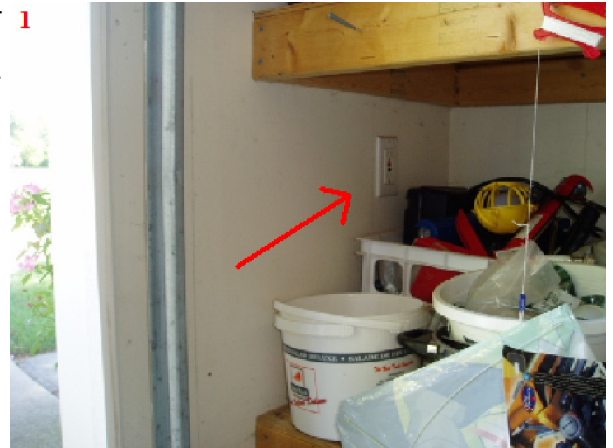
GFCI Protection - Panel, Kitchen, Bathroom, Garage, Exterior

Note: To reset the garage and exterior wall mounted receptacles after having been tripped via GFCI, locate the receptacle at the right of the overhead garage door and reset it by depressing the red reset button.

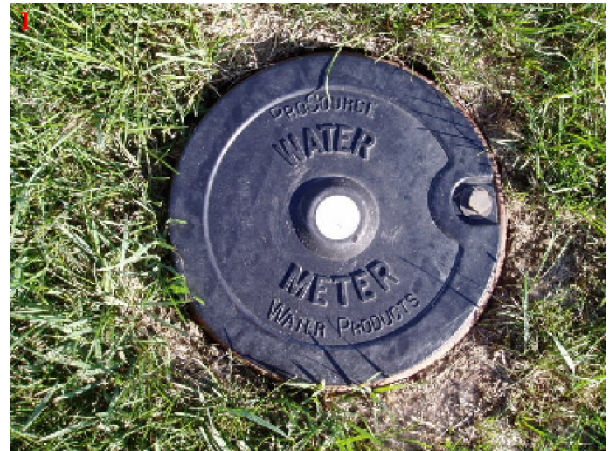
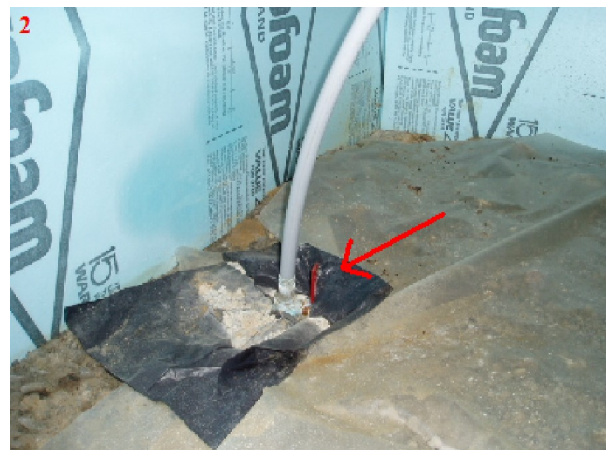
Location of Water Main Valve - Meter Pit

The municipal water main shutoff is located in a meter pit in the front yard. The main valve for shutting water off inside the home is located in the front corner of the crawlspace.

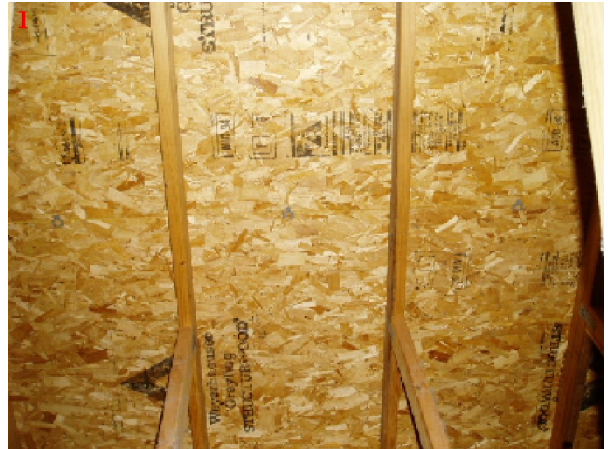
The attic was viewed from the access hole only and therefore information provided about it should be considered incomplete.

Roof Deck - OSB

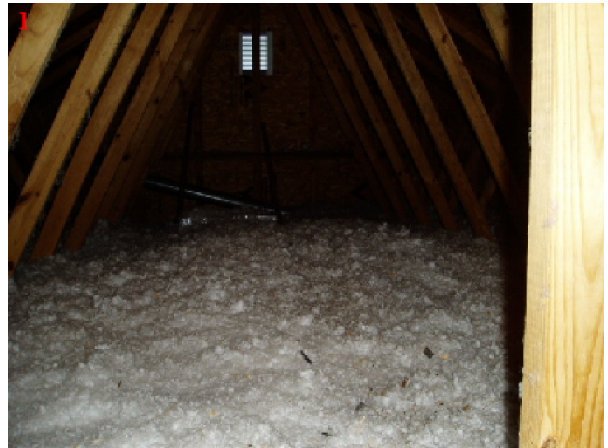
Attic Insulation - Fiberglass, Loose Fill/Blown Insulation, Vapor Retarder Not Readily Visible

During the attic inspection a spot check was performed to determine the presence or absence of a vapor retarder. Based on this spot check there does not appear to be a vapor retarder. Where a vapor retarder is not used the attic typically requires additional ventilation.
